Statutory Licensing Sub-Committee

| 3 | <u>Licensing Act 2003 - Application for a Premises Licence in respect of Rose Garden Banqueting Hall, 295 Parkfield Road, Wolverhampton, WV4 6ED (Pages 3 - 48)</u> |

Noise Management Plan

Blue Acoustics NS357 (V2)

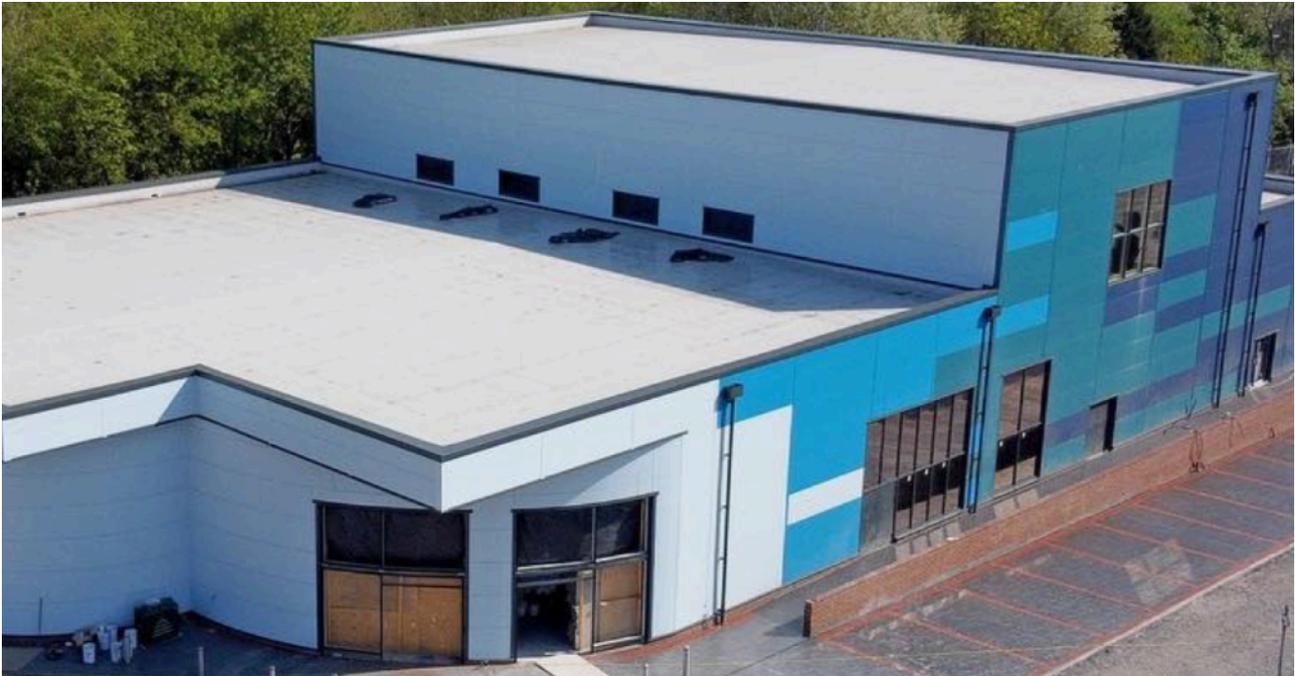
Figure 1 : Rose Gardens

Blue Acoustics has been instructed to carry out an acoustic impact assessment for Rose gardens Banqueting Suite in Wolverhampton. The suite comprises a main hall and associated lobby area on the ground floor, and a smaller yet substantial function room on the 1st floor.

The suite is to be used for a range of private hire functions, notably weddings which often feature live music and DJs, and are known to generate very high music noise levels with significant bass content. As such, the building has been designed to minimise noise breakout through the construction of high mass concrete block cavity wall and suspended ceiling systems.

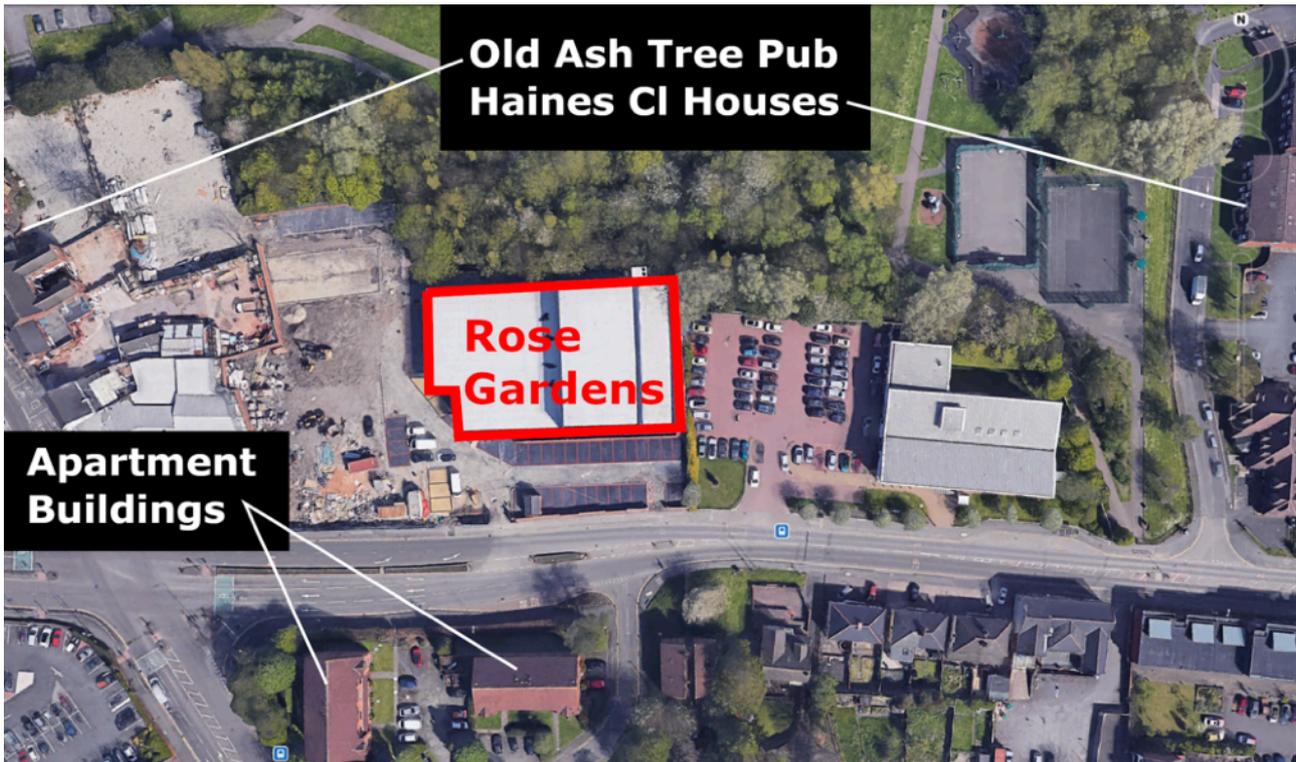
Figure 3 : Aerial view of site in relation to receptors

To the south is Parkfield Road and further from this are several apartment buildings at approx 50m. To the east of these are a row of houses stretching down Parkfield Road.

To the west is the site car park and further to this is a row of shops along Dudley Road ranging 70m to 100m. It is unknown whether or not these are occupied at 1st floor level and so all measurements have been made to the Old Ash Tree pub where it is known that 1st floor accommodation exists.

To the east is a medical centre and associated car park. Recreational sports facilities in Phoenix park are just to the north of the centre. Further west across the park are a number of dwellings in Haines Close, at approx. 130m from the site. To the north is Phoenix park.

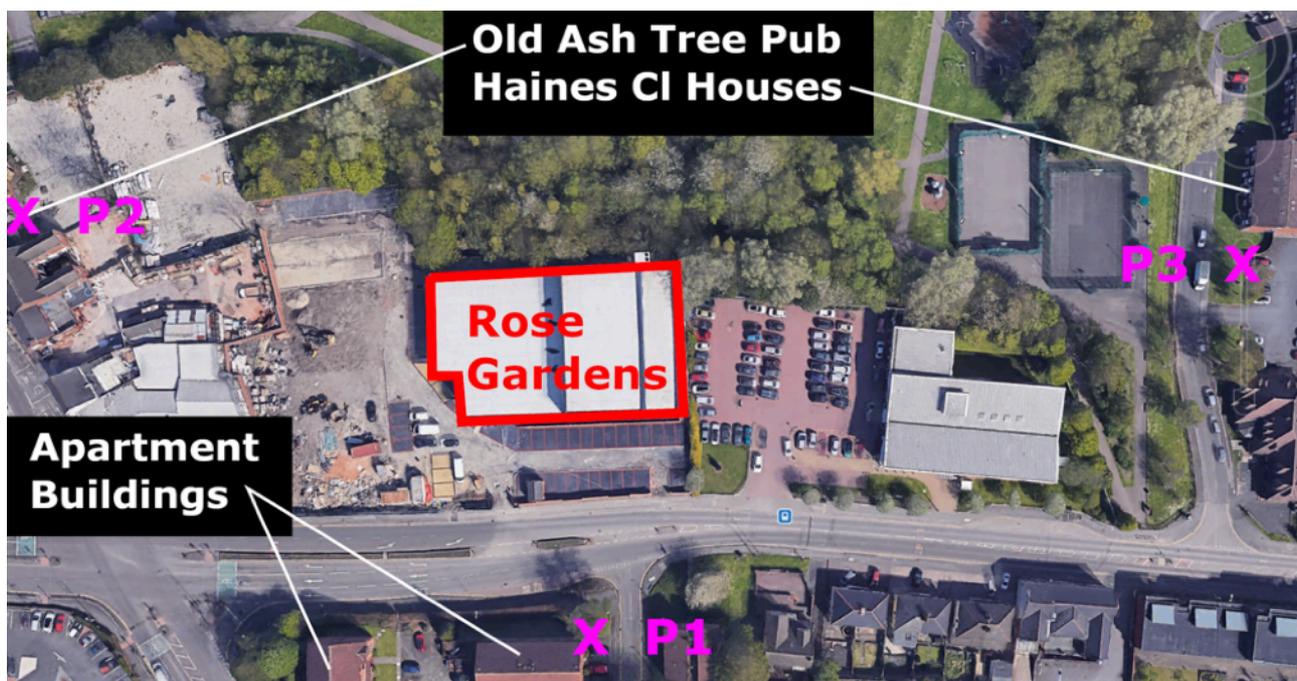
Figure 4 : Aerial view of measurement positions

5.3 Measurement Positions

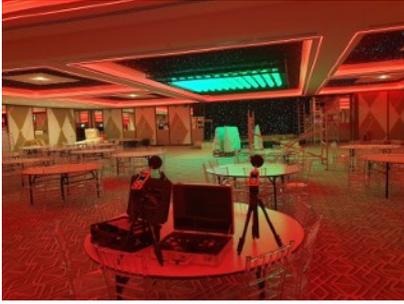
Position	Description	Image
Main Hall	Source room measurement taken by moving arc procedure at the centre of the room

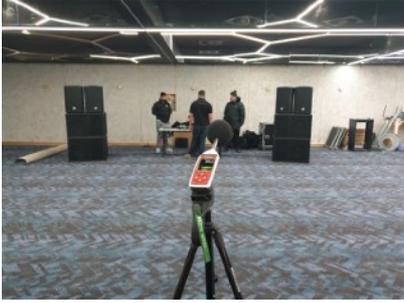
Function Room	Source room measurement taken by moving arc procedure at the centre of the room

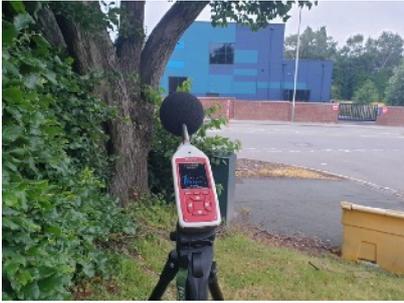
P1	Taken in line with the front facade of the flats opposite, 3.5m from the east end of the eastern most apartment building.

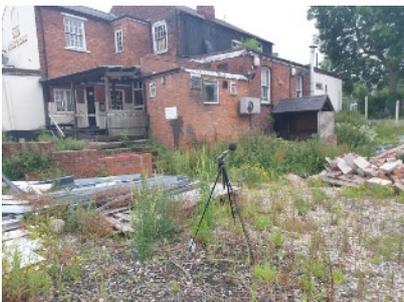
P2	Taken 3.5m from the rear facade of the rear facade of the pub.

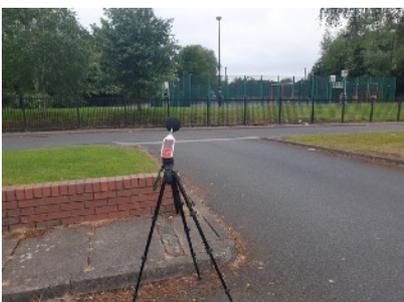
P3	Taken in line with the nearby dwellings in the adjacent car park.

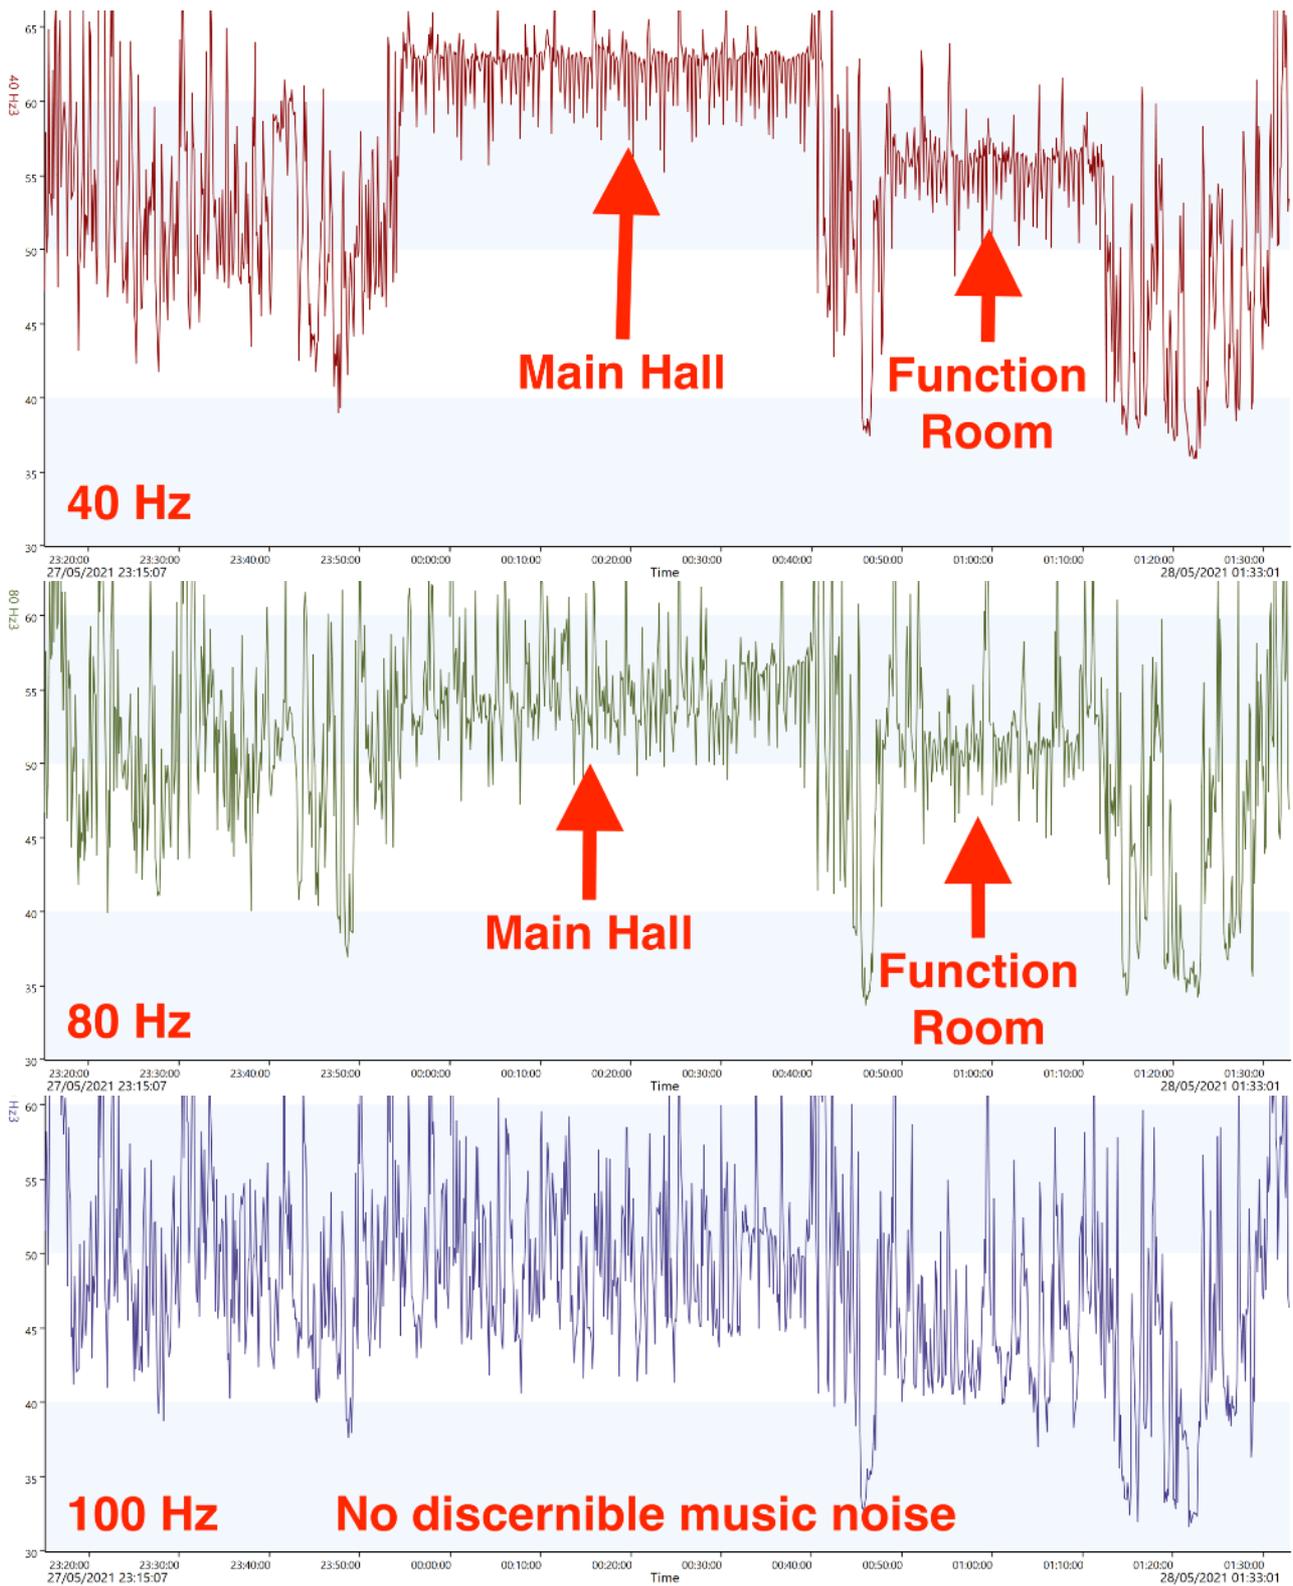
Figure 5 : 40Hz, 80Hz & 100Hz 1/3 Octave band measurements at NSR 1

To ensure music noise was easily recognisable from the measurement data, the track was edited to include a 5s period of silence after every 30s. This method generates visually distinguishable square shaped forms within the low frequency data graph, and allows for better recognition against the residual noise climate.

The following graphs demonstrate this principal. The influence of music noise is clearly visible in the 40Hz 1/3 octave band, with the 5s silences showing as periodic dips in noise level. However, it becomes less visible as frequency increases and is distinctly less apparent in the 80Hz band, becoming un-measurable in the adjacent 100Hz band as it is lost in the residual noise.

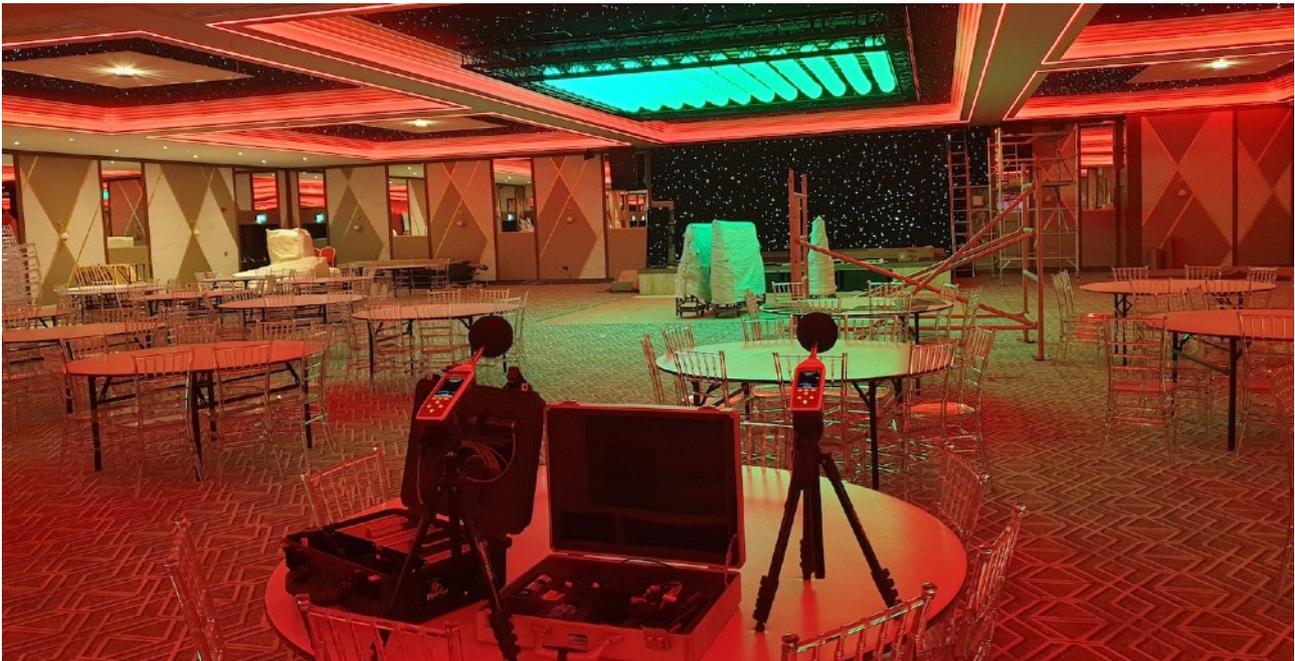
Figure 6 : Main hall

The following tables detail the test result data for the main hall. The measurement data is presented in 1/3 octave un-weighted format between 31.5Hz - 160Hz.

The test results indicate that there is no significant difference in low frequency noise leakage through the lobby roof with the main hall doors open or closed, except for a +4dB rise in the 40hz band. This is assumed to be a result of the fact that the noise is already reverberating through the structure, with internal door states having little effect on structure borne sound transmission.

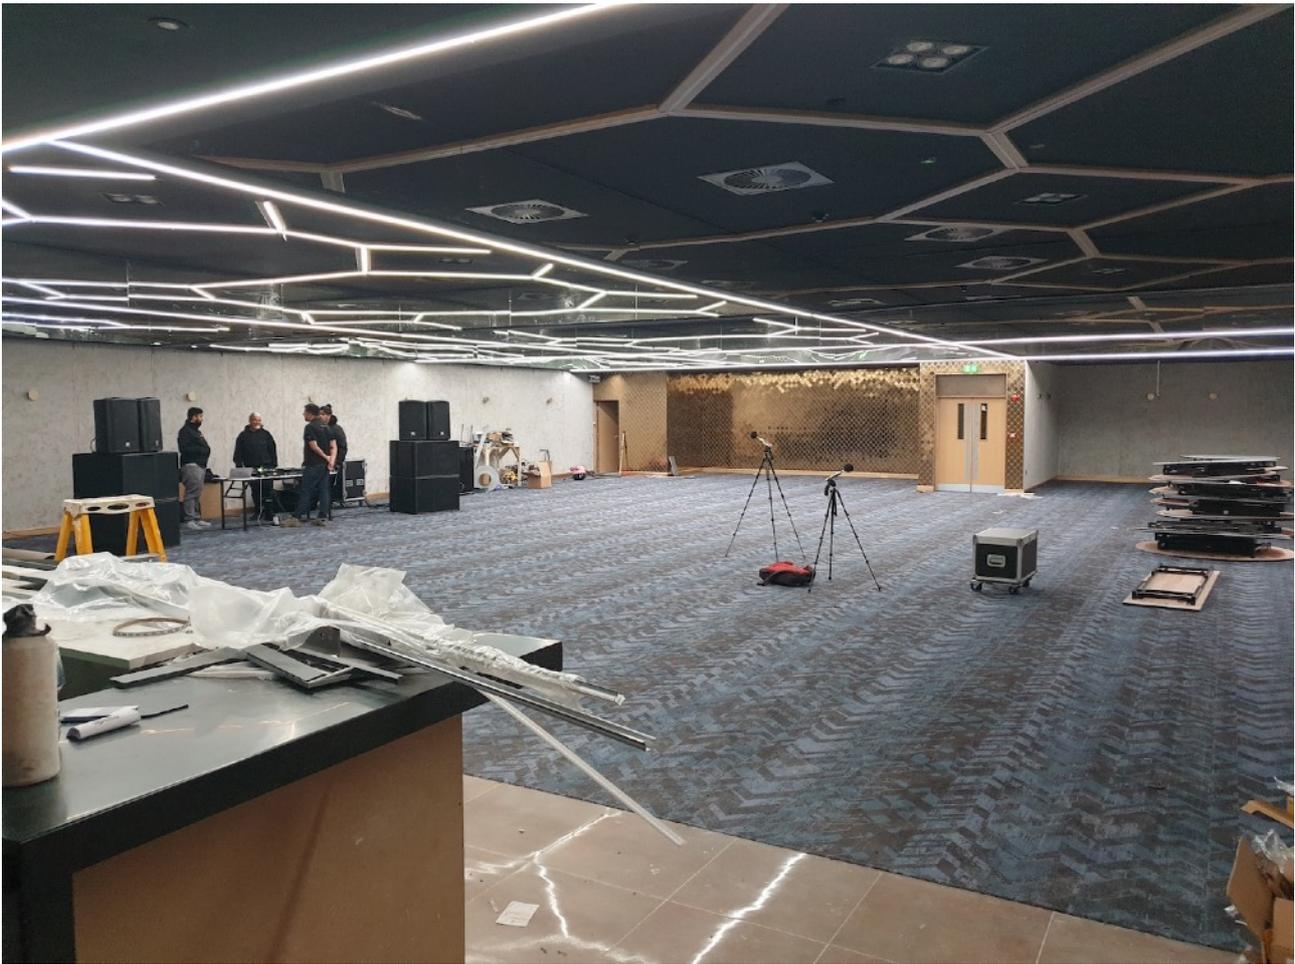
Figure 7 : Function room

The function room roof is the weakest component of the building. It is relatively low, with a floor to roof distance of approx. 5m.

The data indicates that the function room breakout noise registers greatest at NSR 2 (The pub). This is assumed to be caused by sound easily penetrating the western wall, which is significantly lower in mass than the main hall walls.

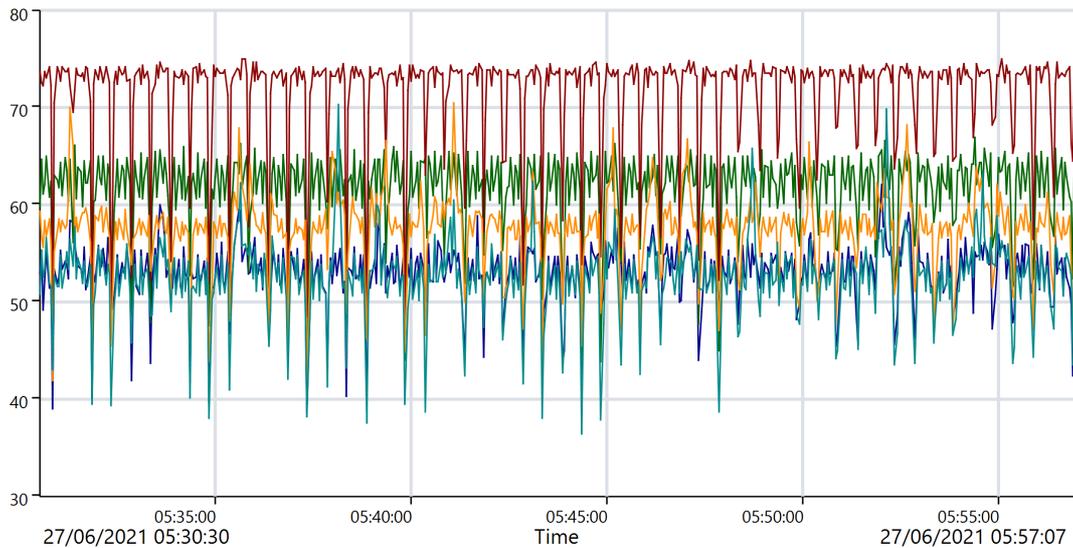
Period 27/06/2021 05:30:30 - 27/06/2021 05:57:07

Legend	31.5 Hz3	40 Hz3	50 Hz3	63 Hz3	80 Hz3
Value	53.8 dB	62.6 dB	72.8 dB	58.8 dB	54.4 dB

These values have been recalculated due to the large number of samples displayed.

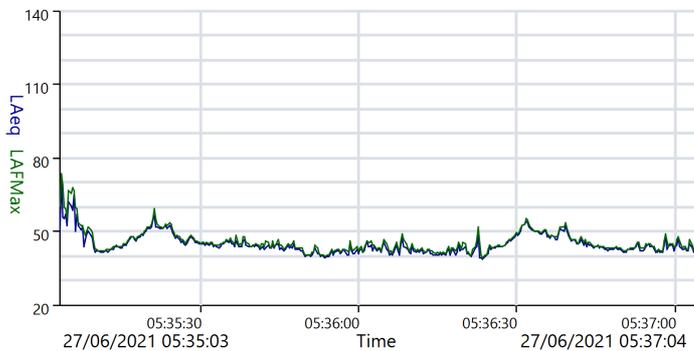
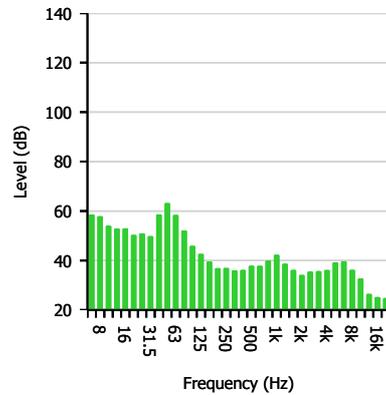
Name	Main Room (Pub)			
Time	27/06/2021 05:35:03	Person	Place	Project
Duration	00:02:01			Rose Gardens
Instrument	G068016, CR:171B			
Calibration				
Before	27/06/2021 04:12	Offset	0.57 dB	After
				28/06/2021 15:53
				Offset 0.15 dB

Basic Values		Statistical Levels (Ln)	
L _{Aeq}	49.6 dB	LAF1	59.6 dB
L _{AE}	70.4 dB	LAF5	52.0 dB
L _{AFMax}	73.3 dB	LAF10	50.4 dB
		LAF50	43.5 dB
		LAF90	40.9 dB
		LAF95	40.2 dB
		LAF99	39.4 dB

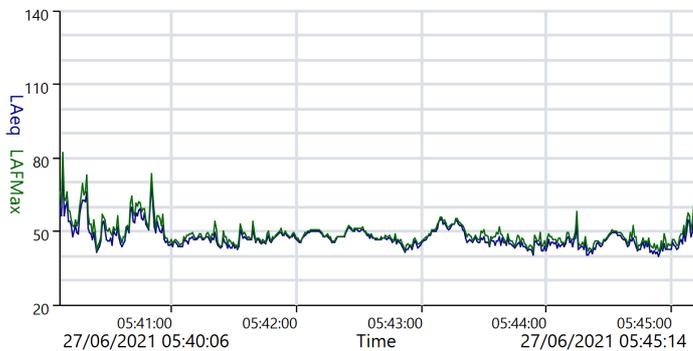
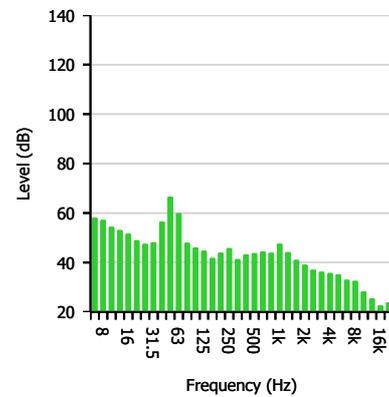
Name	Main Room (Haines Close)			
Time	27/06/2021 05:40:06	Person	Place	Project
Duration	00:05:08			Rose Gardens
Instrument	G068016, CR:171B			
Calibration				
Before	27/06/2021 04:12	Offset	0.57 dB	After
				28/06/2021 15:53
				Offset 0.15 dB

Basic Values		Statistical Levels (Ln)	
LAeq	53.2 dB	LAF1	62.2 dB
LAE	78.1 dB	LAF5	55.2 dB
LAFMax	81.8 dB	LAF10	52.5 dB
		LAF50	46.5 dB
		LAF90	42.7 dB
		LAF95	41.9 dB
		LAF99	40.4 dB

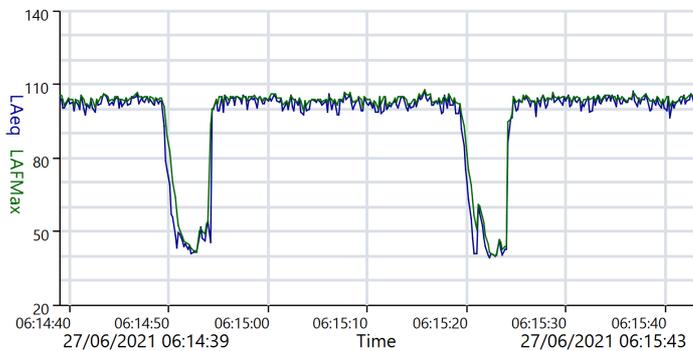
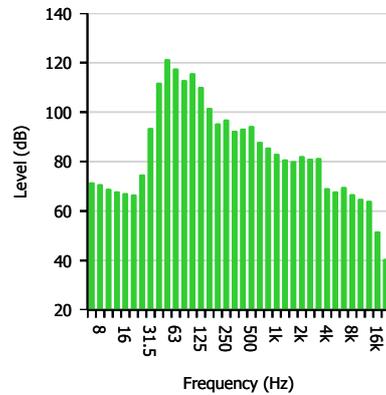
Name	Function Room Source Level			
Time	27/06/2021 06:14:39	Person	Place	Project
Duration	00:01:04			Rose Gardens
Instrument	G068016, CR:171B			
Calibration				
Before	27/06/2021 04:12	Offset	0.57 dB	After 28/06/2021 15:53 Offset 0.15 dB

Basic Values		Statistical Levels (Ln)	
LAeq	102.2 dB	LAF1	105.8 dB
LAE	120.3 dB	LAF5	105.0 dB
LAFMax	107.7 dB	LAF10	104.5 dB
		LAF50	102.3 dB
		LAF90	54.4 dB
		LAF95	44.3 dB
		LAF99	40.3 dB

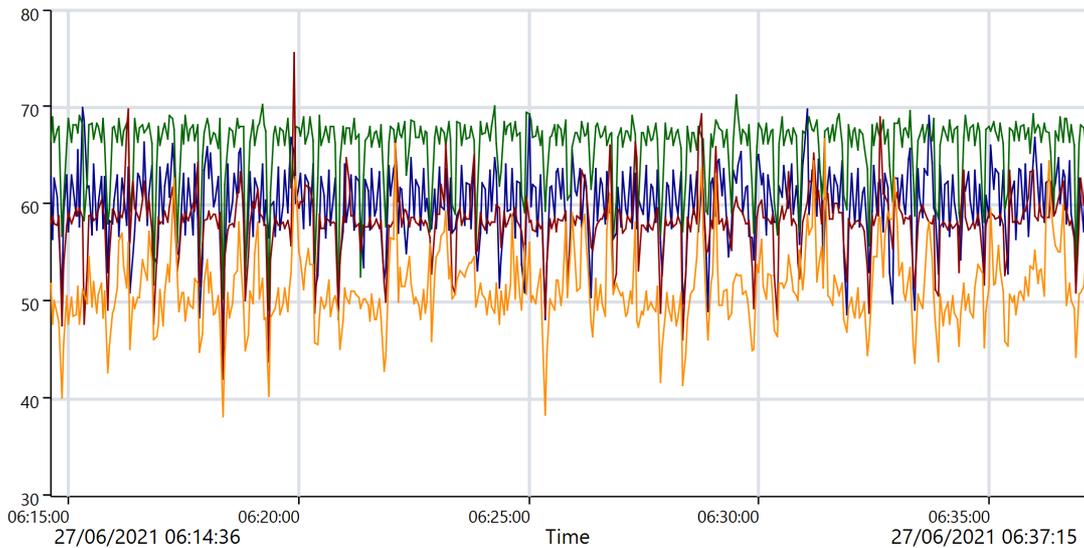
Function Room - NSR 1

Period 27/06/2021 06:14:36 - 27/06/2021 06:37:15

Legend	40 Hz3	50 Hz3	63 Hz3	80 Hz3
Value	61.5 dB	66.8 dB	59.7 dB	53.6 dB

These values have been recalculated due to the large number of samples displayed.

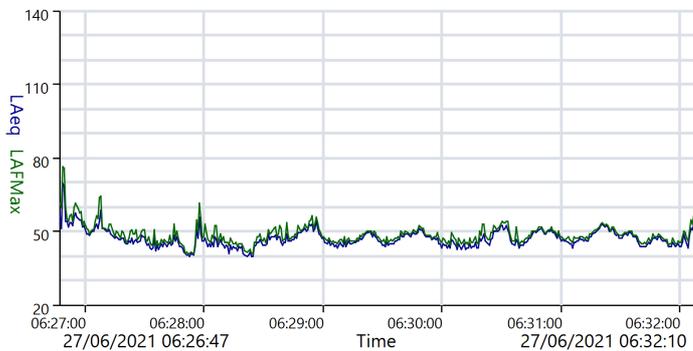
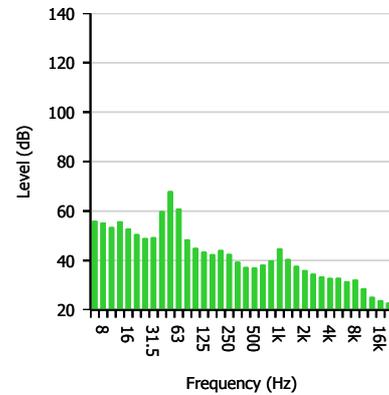
Name	Function Room (Haines Close)			
Time	27/06/2021 06:26:47	Person	Place	Project
Duration	00:05:23			Rose Gardens
Instrument	G068016, CR:171B			
Calibration				
Before	27/06/2021 04:12	Offset	0.57 dB	After
				28/06/2021 15:53
				Offset 0.15 dB

Basic Values		Statistical Levels (Ln)	
LAeq	50.2 dB	LAF1	56.9 dB
LAE	75.3 dB	LAF5	52.7 dB
LAFMax	76.4 dB	LAF10	51.2 dB
		LAF50	46.4 dB
		LAF90	43.1 dB
		LAF95	42.2 dB
		LAF99	39.8 dB
